**Flood Control Project Maintenance  
Levee Inspections**

**Fall 2018 Levee Maintenance Deficiency Summary Report**

**Sacramento River Basin**

## Marysville Levee Commission

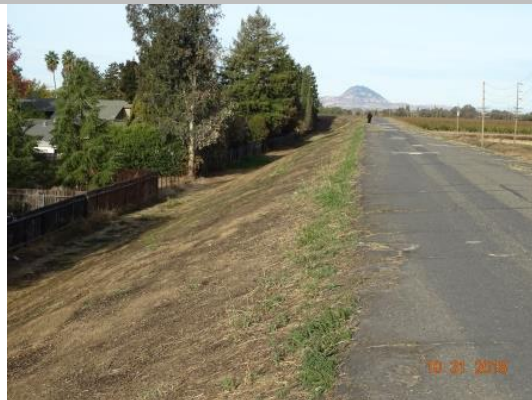
Photo 1 of 1 : FA\_2018\_NA0004\_104\_9\_20181108\_00014.jpg

View looking downstream landside of the well maintained vegetation, Fall 2018.

LM Start	0.00	Rating **	A	Issue No.	10
LM End	3.16	Issue Type +	Ma	Location *	WS
Category	Earthen Levee			GPS Latitude/Longitude	
				Start	End
Item	Vegetation			39.149588°	39.164057°
				-121.601102°	-121.560834°
DWR ID	DWR_NA0004_01_f_2018_10				
Comment Code					
V1 : Control annual grass and weeds on the levee slopes and easements.					
Inspector Comment					
The annual vegetation is well maintained, Fall 2018.

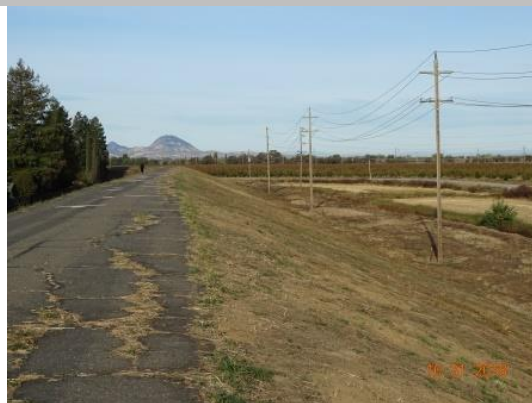
Photo 1 of 1 : FA\_2018\_NA0004\_104\_10\_20181108\_00015.jpg

View looking downstream waterside of the well maintained vegetation, Fall 2018.

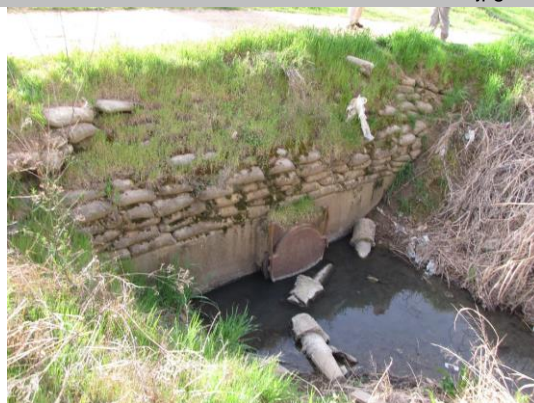
Photo 1 of 3 : UCIP\_FA\_2018\_52792\_69744.jpg

Comment Code						
Inspector Comment						
FS_ID:52792						
DS_ID:19090						
EP_NO: N/A						
Repair Type: No Action Needed						
Crossing Status: Found						
UCIP Comments:						
FIELD_STRUCT_DESC: 36-inch corrugated metal drainage pipe through levee, 27 feet below crown. Flap gate and concrete "U" headwall on waterside (WS) end. Slide gate in 48-inch corrugated metal riser on WS slope of pipe. Steel walkway to control gate. Outfall drains from Ellis Lake. Concrete headwall at both toes. Concrete base under riser units. Steel riser unit and slide gate added under Permit No. 4041, 1962-Marysville Levee Commission. [Additional Reference(s): DWR Levee Logs, 1993 and 2005. USACE Sacramento O&M Manual Unit No. 147, August 1955, (Station 8+48)]						
FS Date: 3/14/2013

View of outlet located on waterward side under toe road.

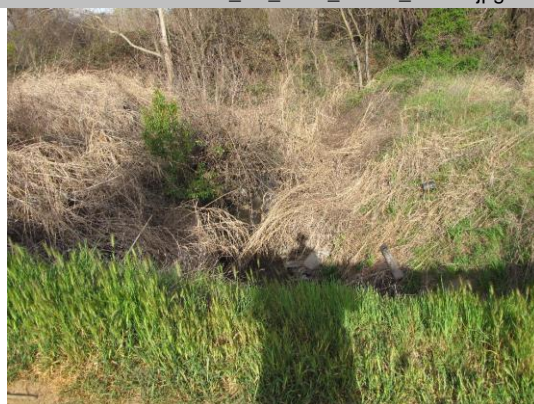
Photo 2 of 3 : UCIP\_FA\_2018\_52792\_69743.jpg

View of waterward side from toe road.

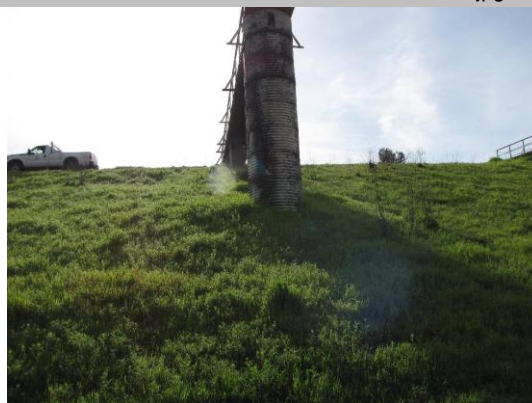
Photo 3 of 3 : UCIP\_FA\_2018\_52792\_69742.jpg

View of waterward slope.

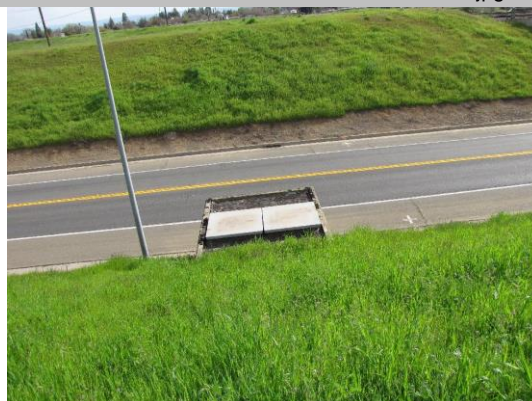
Photo 1 of 3 : UCIP\_FA\_2018\_52796\_69758.jpg

Comment Code						
Inspector Comment						
FS_ID:52796 DS_ID:19100 EP_NO: 14518 Repair Type: Non-Urgent Crossing Status: Indicator Found UCIP Comments: 03/14/2013 Recommend having owner removing tall grass along slopes to properly inspect signs of pipe failure. (DWR UCIP - O. Magana) FIELD_STRUCT_DESC: 1 of 2: 10-inch steel drainage pipe through levee, 4 feet below crown. Flap gate on waterside (WS) end. Concrete vault on WS shoulder. Metal meter box on the landside (LS) shoulder. Pump placed on concrete footings at toe of LS slope. Drainage for underpass. Pipes approximately 2.5-feet apart. (10-inch pipe removed and replaced with new 10-inch pipe authorized under Permit No. 14518, 1987-State Department of Transportation). [Additional Reference(s): DWR Levee Logs, 1993 and 2005] FS Date: 3/14/2013

View of landward side.

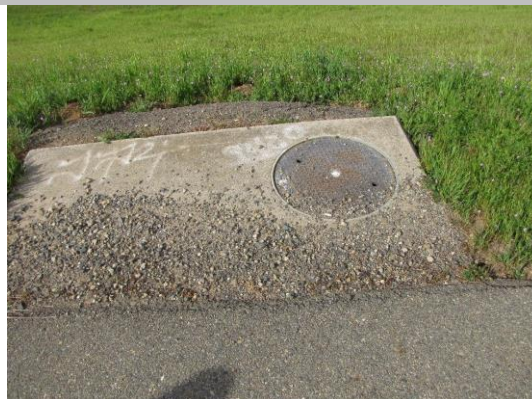
Photo 2 of 3 : UCIP\_FA\_2018\_52796\_69757.jpg

Concrete vault on waterward shoulder with manhole.

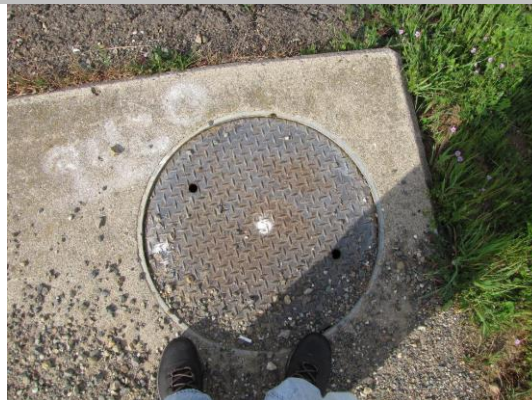
Photo 3 of 3 : UCIP\_FA\_2018\_52796\_69756.jpg

Close up view of manhole.

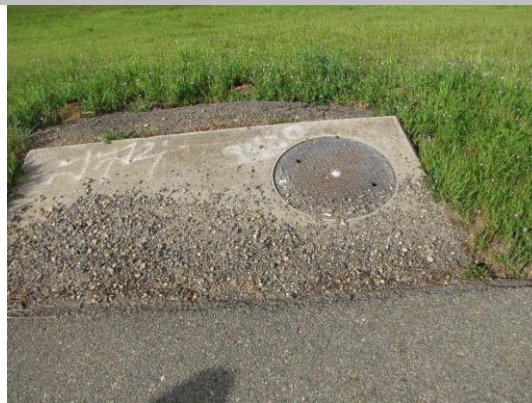
Photo 2 of 3 : UCIP\_FA\_2018\_52797\_69761.jpg

Concrete vault located on waterward shoulder.

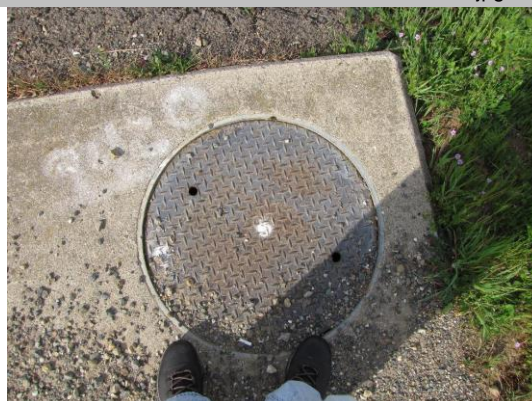
Photo 3 of 3 : UCIP\_FA\_2018\_52797\_69760.jpg

Close up of manhole.

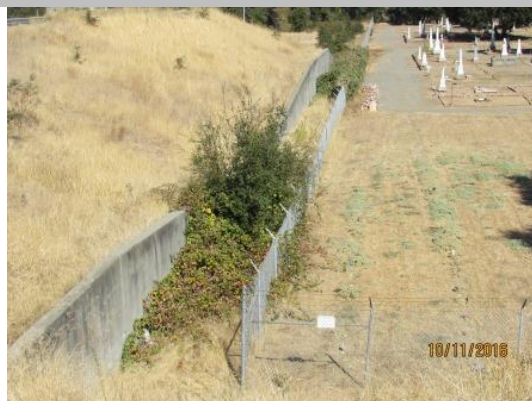
Photo 1 of 1 : FA\_2018\_NA0004\_104\_36\_20180918\_00001.jpg

LM Start	0.97	Rating **	M	Issue No.	36
LM End	1.19	Issue Type +	En	Location *	WS
Category	Earthen Levee			GPS Latitude/Longitude	
				Start	End
Item	Encroachments			39.159210 °	39.161576 °
				-121.590033 °	-121.590721 °
DWR ID	DWR_NA0004_01_f_2013_36				
Comment Code					
RW : Retaining Wall					
Inspector Comment					
Concrete retaining wall cut into levee toe, no permit found.

View of the concrete retaining wall at the toe of the levee on the waterward side looking downstream.

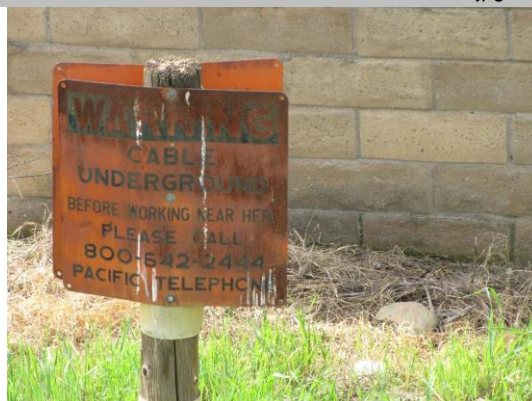
Photo 1 of 3 : UCIP\_FA\_2018\_52799\_69766.jpg

Comment Code					
Inspector Comment					
FS_ID:52799 DS_ID:19115 EP_NO: 12878 Repair Type: Non-Urgent Crossing Status: Indicator Found UCIP Comments: 03/14/2013 Need to contact owner to determine additional information about crossing and alignment. (DWR UCIP - O. Magana) FIELD_STRUCT_DESC: 24-inch steel pipe encasing 4-inch polyvinyl chloride (PVC) communications extension through the levee, annular gap grouted, 8 feet below levee crown. Cutoff wall (12x12x20-inch) around extension from levee slopes. (underground communication extension authorized under Permit No. 12878, 1980-Pacific Telephone and Telegraph Company). [Additional Reference(s): DWR Levee Logs, 1993 and 2005] FS Date: 3/14/2013

Marker on landward side.

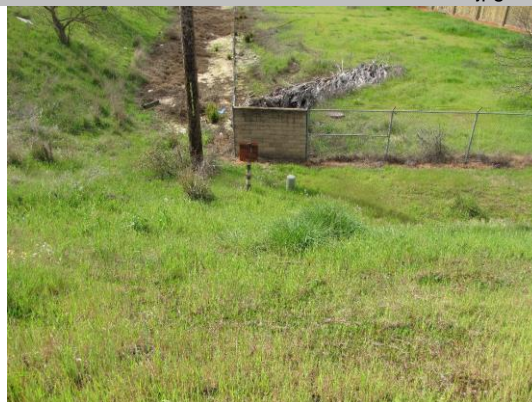
Photo 2 of 3 : UCIP\_FA\_2018\_52799\_69765.jpg

View of landward side.

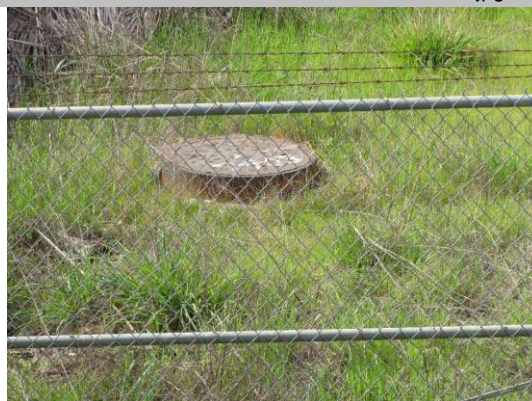
Photo 3 of 3 : UCIP\_FA\_2018\_52799\_69764.jpg

Manhole located behind fenced area on landward side.

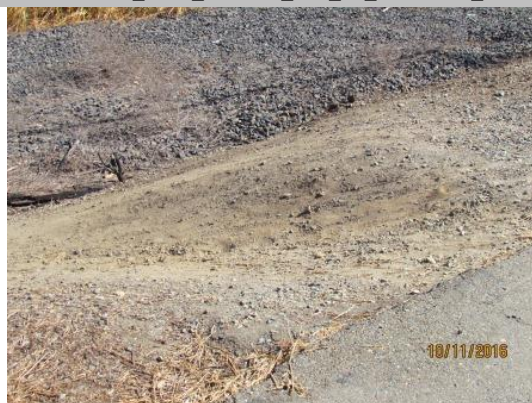
Photo 1 of 1 : FA\_2018\_NA0004\_105\_13\_20180918\_00004.jpg

LM Start	0.82	Rating **	M	Issue No.	13
LM End	0.82	Issue Type +	Ma	Location *	LS
Category	Earthen Levee			GPS Latitude/Longitude	
				Start	End
Item	Slope Stability			39.138827 °	39.138827 °
				-121.599530 °	-121.599530 °
DWR ID	DWR_NA0004_02_f_2016_13				
Comment Code					
S2 : Repair the levee slope damaged by foot traffic and prevent access where possible.					
Inspector Comment					
Foot path depression in the landside levee slope needs to be repaired.

View of foot path depression in the landside levee slope.

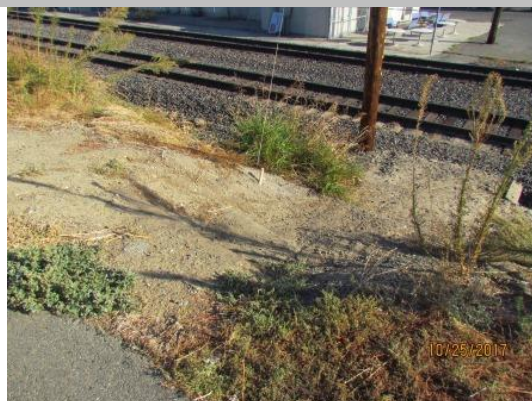
Photo 1 of 1 : FA\_2018\_NA0004\_105\_14\_20180918\_00005.jpg

LM Start	0.85	Rating **	M	Issue No.	14
LM End	0.85	Issue Type +	Ma	Location *	LS
Category	Earthen Levee			GPS Latitude/Longitude	
				Start	End
Item	Slope Stability			39.138463 °	39.138463 °
				-121.599168 °	-121.599168 °
DWR ID	DWR_NA0004_02_f_2016_14				
Comment Code					
S2 : Repair the levee slope damaged by foot traffic and prevent access where possible.					
Inspector Comment					
Remove steps that are cut into levee slope, Fall 2017.

View of steps for foot path in the landside levee slope.

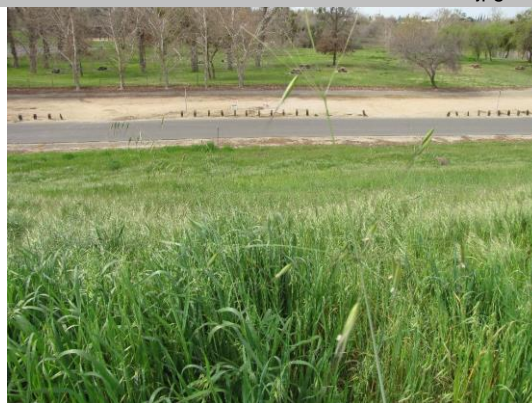
Photo 1 of 3 : UCIP\_FA\_2018\_52808\_69802.jpg

LM Start	0.87	Rating **	M	Issue No.	15
LM End	0.87	Issue Type +	En	Location *	
Category	Supplemental			GPS Latitude/Longitude	
				Start	End
Item	DWR UCIP Field Study			39.138269 °	39.138269 °
				-121.599004 °	-121.599004 °
DWR ID	19123				
Comment Code					
Inspector Comment					
FS_ID:52808 DS_ID:19123 EP_NO: N/A Repair Type: Non-Urgent Crossing Status: Indicator Found UCIP Comments: 03/15/2013 Unable to tell if crossing goes through levee; according to Frank Miller crossing does not cross levee. Need to contact owner to confirm alignment. (DWR UCIP - O. Magana) FIELD_STRUCT_DESC: Fiber optics communication line of unknown material through levee at an unknown depth below the crown. Marker on waterside (WS) shoulder. [Additional Reference(s): DWR Levee Logs, 1993 and 2005] FS Date: 3/15/2013

View of waterward slope.

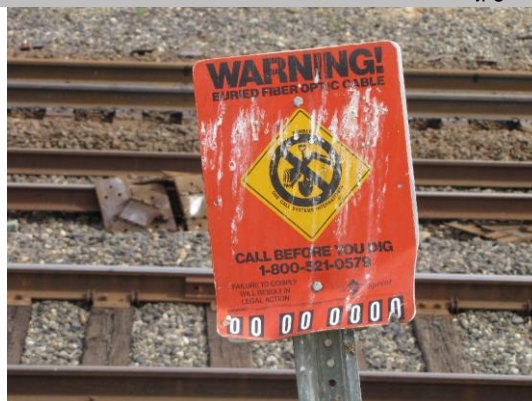
Photo 2 of 3 : UCIP\_FA\_2018\_52808\_69801.jpg

Buried fiber optical cable marker with contact information located on landward shoulder.

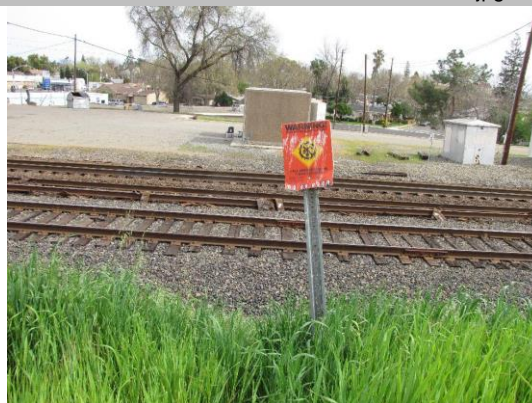
Photo 3 of 3 : UCIP\_FA\_2018\_52808\_69800.jpg

View of landward side with bldg that could be associated with cable line.

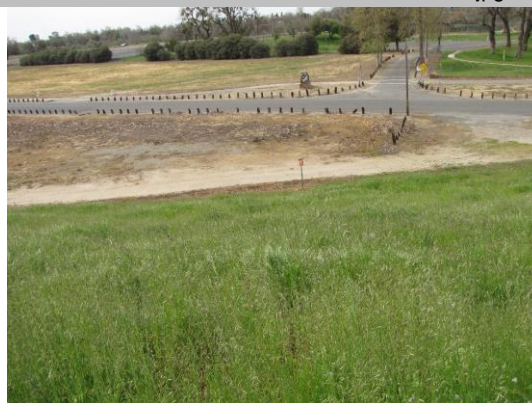
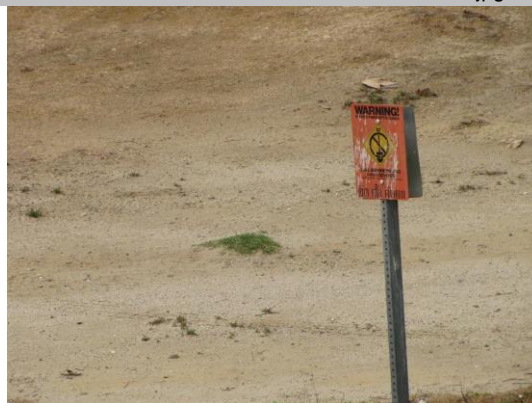
FS\_ID:52809  
DS\_ID:19104  
EP\_NO: N/A  
Repair Type: Non-Urgent  
Crossing Status: Indicator Found  
UCIP Comments: 03/15/2013 Unable to tell if crossing goes through levee. Need to contact owner to confirm alignment. (DWR UCIP - O. Magana)  
FIELD\_STRUCT\_DESC: 12-inch high-density polyethylene (HDPE) conduit, with electrical lines, through the levee at an unknown depth through the levee. Extends to controller cabinet within the overflow area.  
FS Date: 3/15/2013

View of markers located on waterward toe.

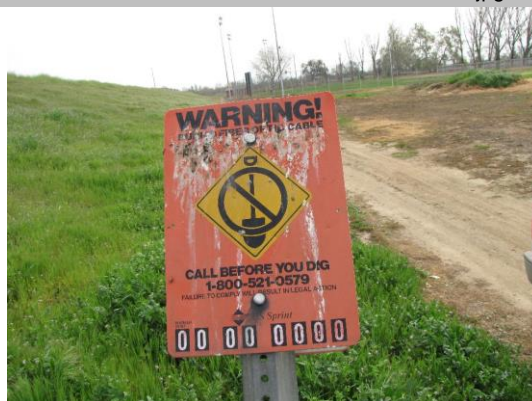
Photo 3 of 3 : UCIP\_FA\_2018\_52809\_69806.jpg

LM Start	0.91	Rating **	M	Issue No.	16 (cont)	
LM End	0.91	Issue Type +	En	Location *		
Category	Supplemental			GPS Latitude/Longitude		
				Start	End	
Item	DWR UCIP Field Study			39.137749 °	39.137749 °	
				-121.598560 °	-121.598560 °	
DWR ID	19104					
Comment Code						
Inspector Comment						
FS_ID:52809						
DS_ID:19104						
EP_NO: N/A						
Repair Type: Non-Urgent						
Crossing Status: Indicator Found						
UCIP Comments: 03/15/2013 Unable to tell if crossing goes through levee. Need to contact owner to confirm alignment. (DWR UCIP - O. Magana)						
FIELD_STRUCT_DESC: 12-inch high-density polyethylene (HDPE) conduit, with electrical lines, through the levee at an unknown depth through the levee. Extends to controller cabinet within the overflow area.						
FS Date: 3/15/2013

Close up of markers located at toe of waterward side.

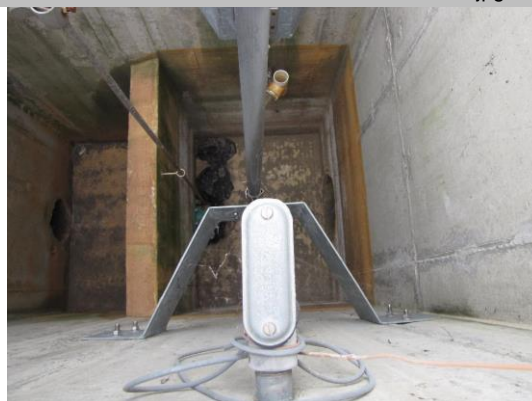
Photo 1 of 3 : UCIP\_FA\_2018\_52811\_72681.jpg

Comment Code						
Inspector Comment						
FS_ID:52811 DS_ID:25055 EP_NO: N/A Repair Type: Non-Urgent Crossing Status: Found UCIP Comments: 09/14/2018 Pipe size was changed from 10-inch to 12-inch based on drawings made available through Permit 15178 and 15178-1. (DWR UCIP - O. Magana) 03/14/2013 Appears that crossing is currently not in use. If crossing is to be abandoned, owner will need to contact CVFPB to coordinate about proper removal. (DWR UCIP - O. Magana) FIELD_STRUCT_DESC: 12-inch sewer line visible on landside (LS). According to Marysville Treatment Plant Manager this crossing was installed in 1995-1996. Coordinates for box located on LS: 39.135185, -121.593254. Note coordinates used for levee crossing are projected coordinates. 12-inch gravity flow pipelines goes through levee and the 36-inch pipeline parallels with the waterside toe of the right bank levee of the Yuba River. (12-inch extending-to-36-inch-diameter chlorine contact pipe line authorized under Permit 16055, 1993-City of Marysville; related permit - existing 12-inch line connects to effluent splitter box located southwest at the City of Marysville Effluent Disposal Ponds along the right bank of the Yuba River and new 24-inch installled at existing effluent splitter box and connects to the Proposed ponds along the left bank of the Yuba River work authorized under Permit 15178, 1989 - City of Marysville Department of Public Works) FS Date: 3/14/2013

Inside view of concrete box.

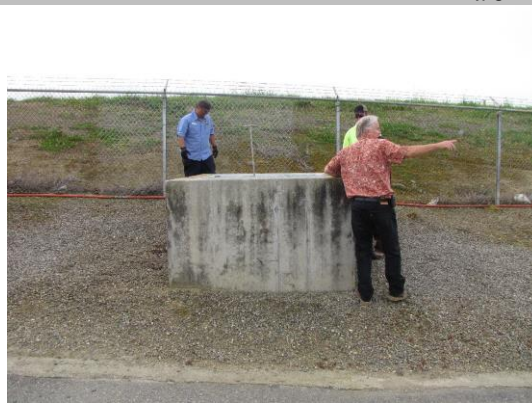
Photo 2 of 3 : UCIP\_FA\_2018\_52811\_72680.jpg

View of concrete box located on landward side--crossing not in use according to Marysville Sewage Treatment Plant Manager.

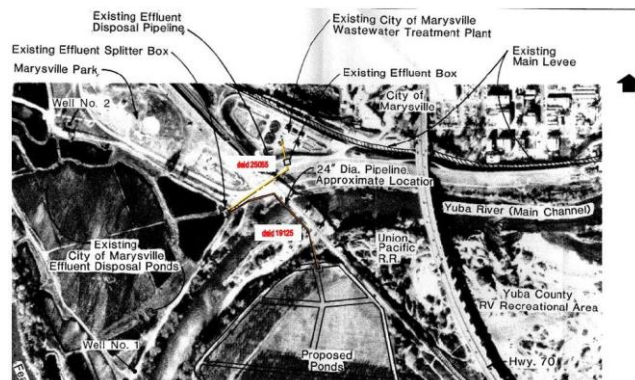
Photo 3 of 3 : UCIP\_FA\_2018\_52811\_77949.jpg

Alignment of crossing through levee per dwgs under Permit 15178 and 15178-1.

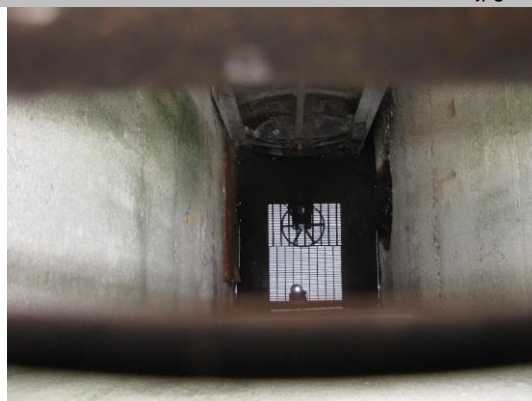
Photo 1 of 3 : UCIP\_FA\_2018\_52812\_69812.jpg

Comment Code						
Inspector Comment						
FS_ID:52812						
DS_ID:19126						
EP_NO: N/A						
Repair Type: Non-Urgent						
Crossing Status: Found						
UCIP Comments: 03/15/2013 Owner will need to coordinate with DWR-Inspector and CVFPB to determine if crossing meets Title 23 requirements for proper abandonment. (DWR UCIP - O. Magana)						
FIELD_STRUCT_DESC: *ABANDONED* 24-inch drainage pipe of unknown material through levee at an unknown depth. Pipe completely grouted in levee section, cut at slopes. Coordinates for box located on landward side: 39.135259, -121.592593. Note coordinates used for levee crossing are projected coordinates. (24-inch pipe grouted within the levee section authorized under Permit No. 4174, 1963-City of Marysville)						
FS Date: 3/15/2013

Abandoned line sealed with metal plate.

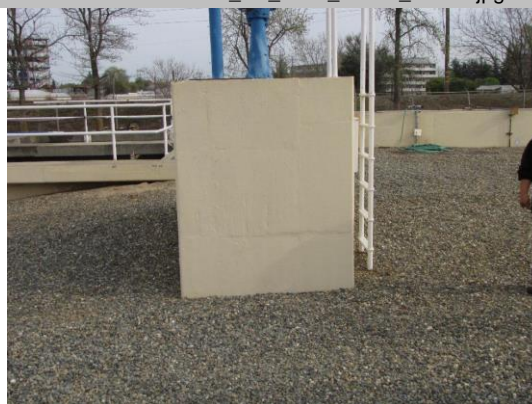
Photo 2 of 3 : UCIP\_FA\_2018\_52812\_69811.jpg

Standpipe where old line is still located.

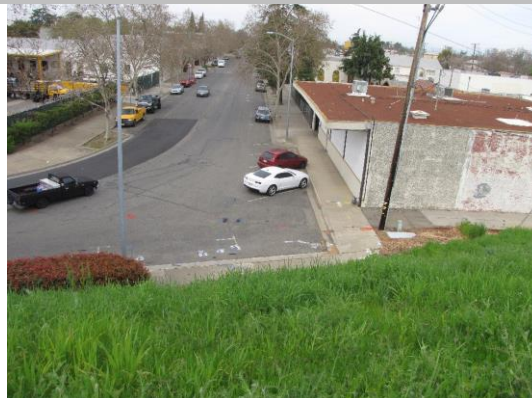
Photo 1 of 2 : UCIP\_FA\_2018\_52815\_72683.jpg

LM Start	0.47	Rating **	M	Issue No.	45
LM End	0.47	Issue Type +	En	Location *	
Category	Supplemental			GPS Latitude/Longitude	
				Start	End
Item	DWR UCIP Field Study			39.135932 °	39.135932 °
				-121.585529 °	-121.585529 °
DWR ID	19133				
Comment Code					
Inspector Comment					
FS_ID:52815 DS_ID:19133 EP_NO: 1983 Repair Type: Non-Urgent Crossing Status: Indicator Found UCIP Comments: 03/15/2013 Need to contact owner. Unable to determine if crossing is still in use. (DWR UCIP - O. Magana) FIELD_STRUCT_DESC: 0.75-inch water line through the levee at an unknown depth through the levee. Water meter at landside (LS) toe. Extends from nearby buildings, bunkers, suction dredge on waterside (WS). (Permit No. 1983, 1959-Yuba River Sand Company). [Additional Reference(s): DWR Levee Logs, 1993 and 2005] FS Date: 3/15/2013

Underground service alert (USA) blue paint indicators of water line present on landward side.

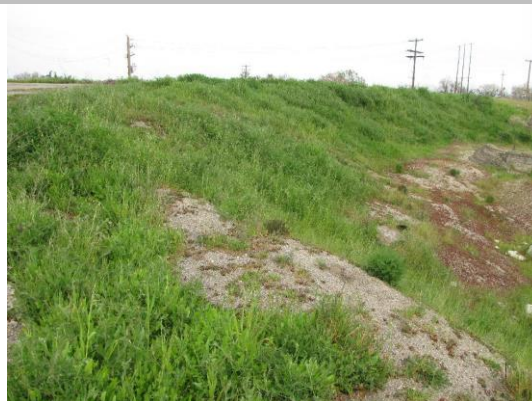
Photo 2 of 2 : UCIP\_FA\_2018\_52815\_72682.jpg

View of waterward slope--unable to confirm if crossing is active--line buried.

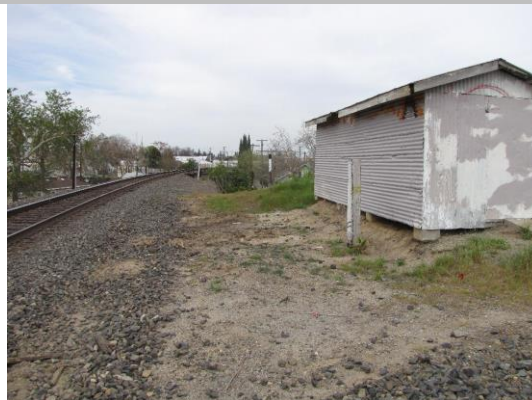
Photo 1 of 3 : UCIP\_FA\_2018\_52819\_72696.jpg

View of landward side.

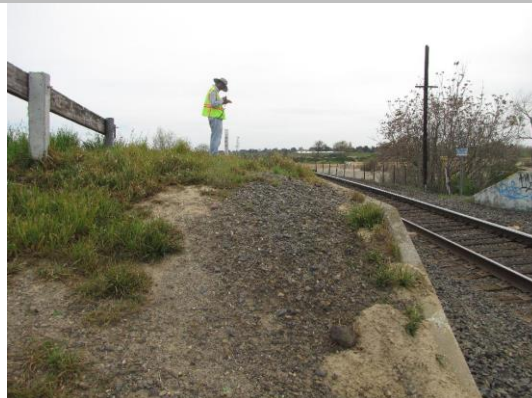
Photo 2 of 3 : UCIP\_FA\_2018\_52819\_72695.jpg

View of landward side.

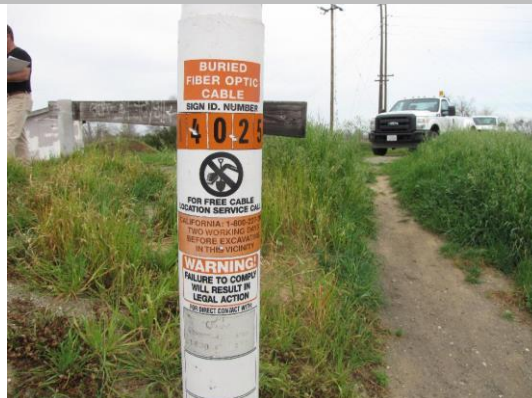
Photo 3 of 3 : UCIP\_FA\_2018\_52819\_72694.jpg

Fiber Optic Cable marker visible on landward side.

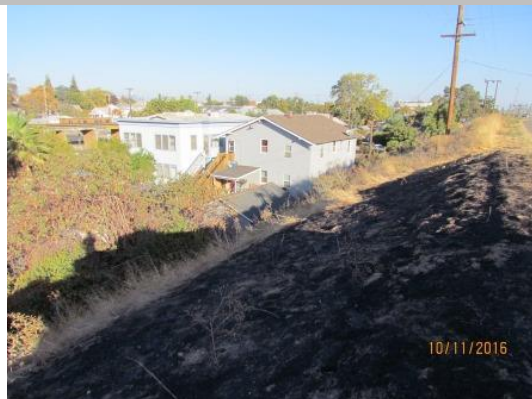
Photo 1 of 1 : FA\_2018\_NA0004\_106\_25\_20180918\_00004.jpg

View of house and shed at the landside levee toe looking upstream.

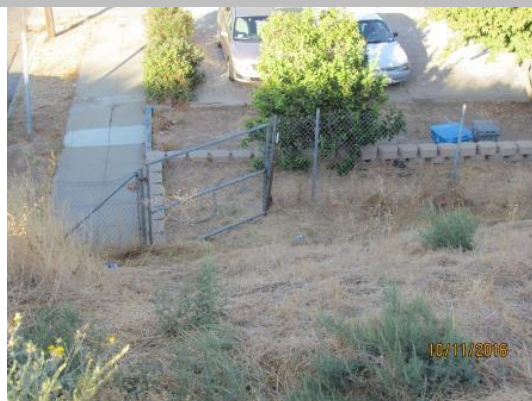
Photo 1 of 1 : FA\_2018\_NA0004\_106\_26\_20180918\_00005.jpg

View of fence that runs along landside levee toe.

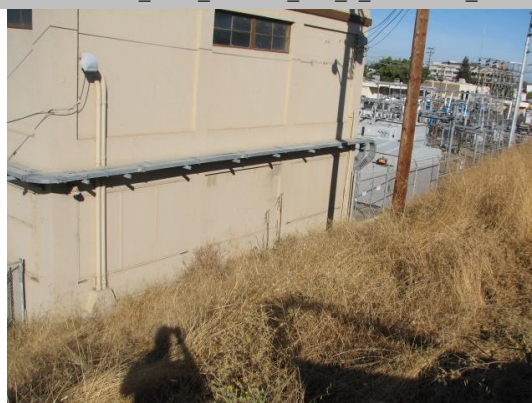
Photo 1 of 1 : FA\_2018\_NA0004\_106\_4\_20180918\_00001.jpg

Building encroaching at landside levee toe.

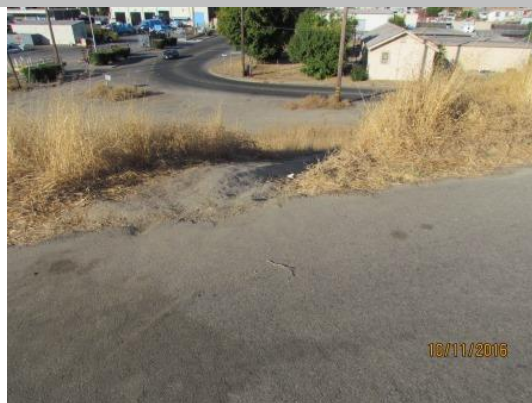
Photo 1 of 1 : FA\_2018\_NA0004\_106\_30\_20180918\_00006.jpg

View of path cut in by foot traffic on the landside slope.

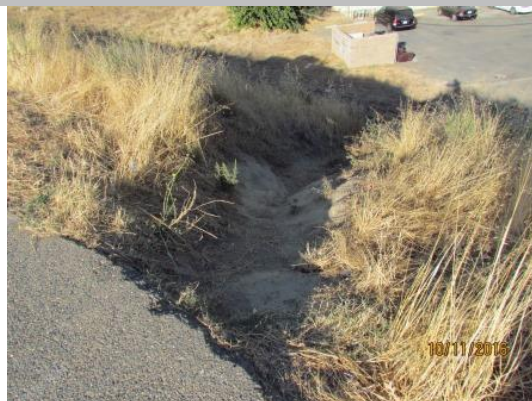
Photo 1 of 1 : FA\_2018\_NA0004\_106\_33\_20180918\_00008.jpg

View of path cut in by foot traffic on the landside slope that needs repaired.

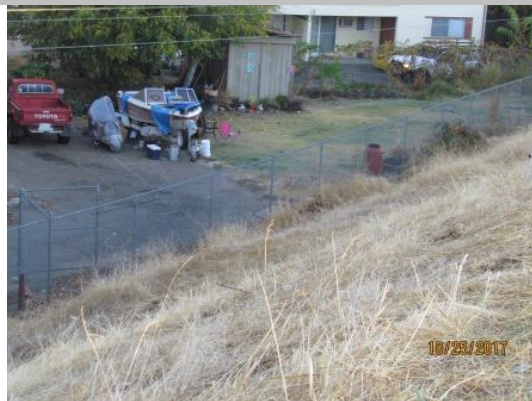
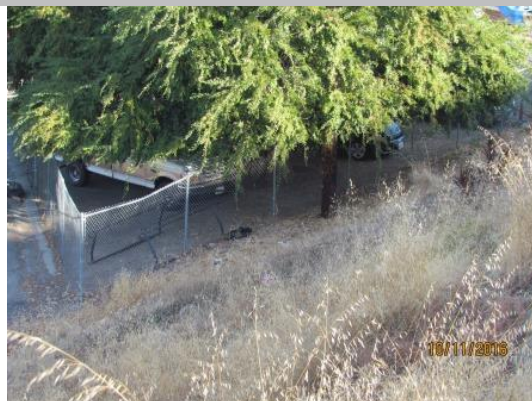
View of fence on the landside toe.

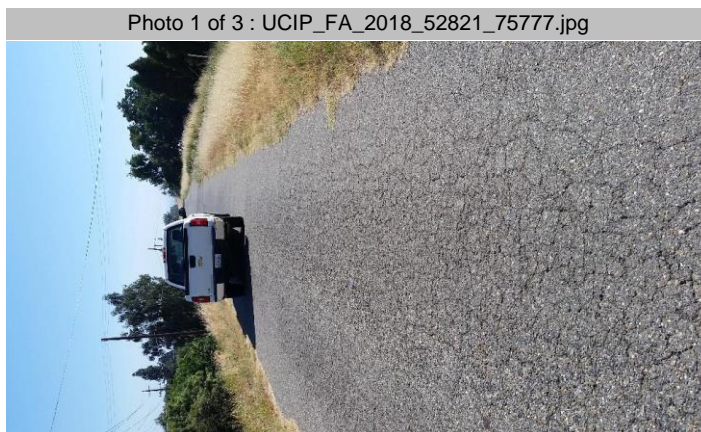
LM Start	1.59	Rating **	M	Issue No.	47
LM End	1.59	Issue Type +	En	Location *	
Category	Supplemental			GPS Latitude/Longitude	
				Start	End
Item	DWR UCIP Field Study			39.148891 °	39.148891 °
				-121.577420 °	-121.577420 °
DWR ID	25468				
Comment Code					
Inspector Comment					
FS_ID:52821 DS_ID:25468 EP_NO: N/A Repair Type: Non-Urgent Crossing Status: Indicator Found UCIP Comments: 6/29/2016 Underground Service Alert (USA) markings visible on levee crown. Unable to determine pipe size, depth below crown, or permit authorizing line. Need to find owner and obtain status of crossing. (DWR UCIP - omagana) FIELD_STRUCT_DESC: Sewer line of unknown material through the levee at an unknown depth. FS Date: 6/29/2016

View of levee crown at crossing.

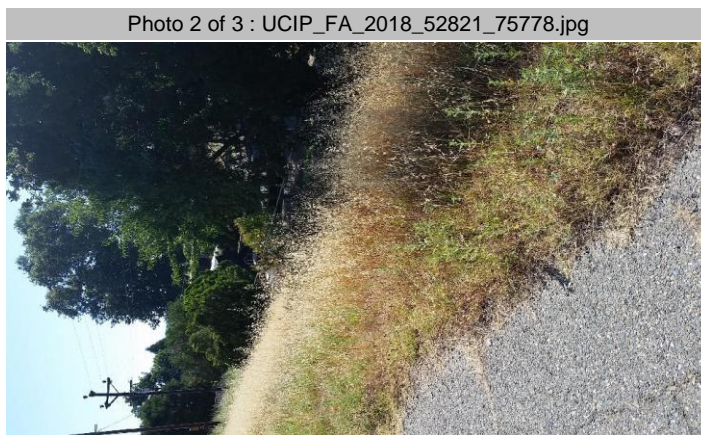
View of WS--dense vegetation on slope.

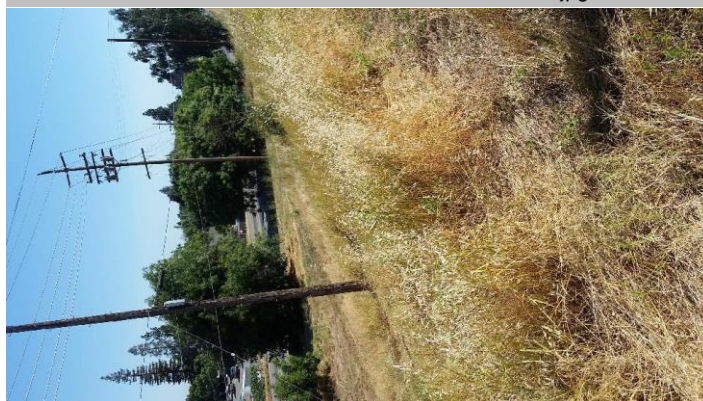
Photo 3 of 3 : UCIP\_FA\_2018\_52821\_75779.jpg

View of LS--dense vegetation on slope.

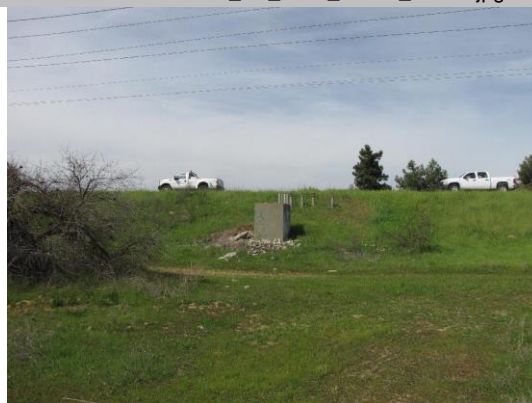
Photo 2 of 3 : UCIP\_FA\_2018\_52824\_69829.jpg

View of waterward side--concrete box and vent pipes located on waterward slope.

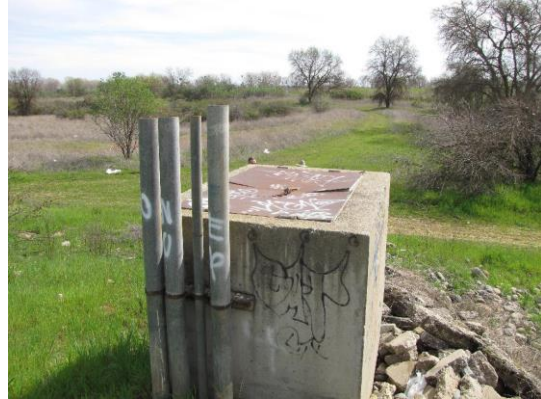
Photo 3 of 3 : UCIP\_FA\_2018\_52824\_69828.jpg

Concrete box and vent pipes located on waterward side.

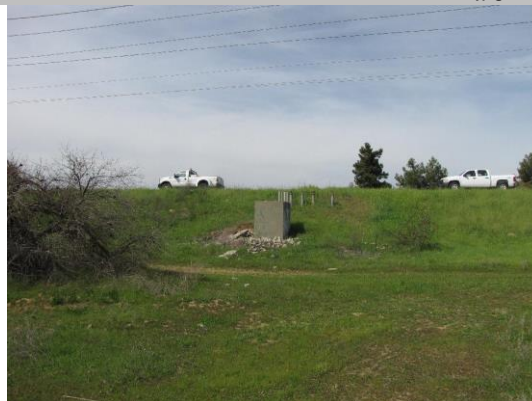
Photo 2 of 3 : UCIP\_FA\_2018\_52825\_69834.jpg

Concrete box and vent pipes located on waterward slope.

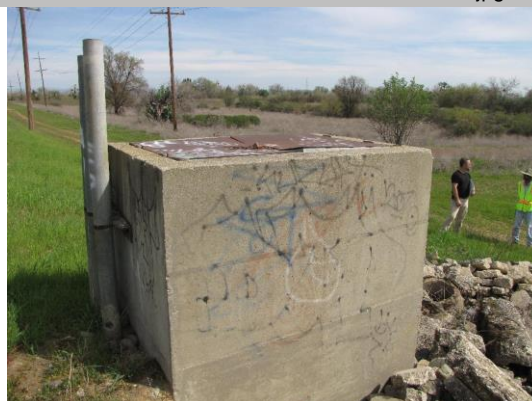
Photo 3 of 3 : UCIP\_FA\_2018\_52825\_69833.jpg

Concrete box located on waterward slope.

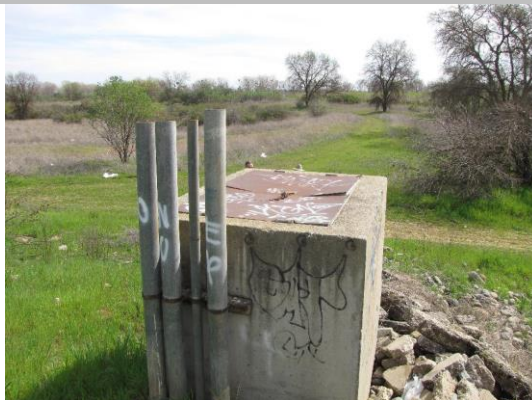
Photo 3 of 3 : UCIP\_FA\_2018\_52826\_69838.jpg

Concrete stand pipe located on waterward shoulder.

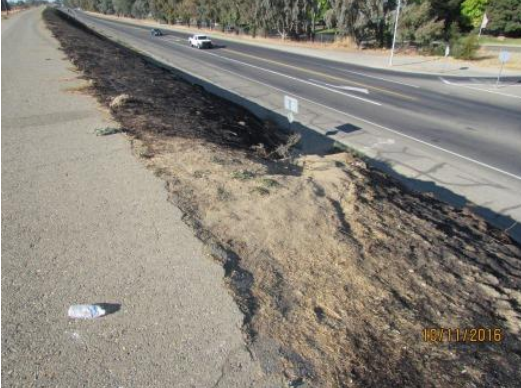
Photo 1 of 1 : FA\_2018\_NA0004\_106\_41\_20180918\_00013.jpg

View looking downstream of foot path that has cut into the roadside slope.

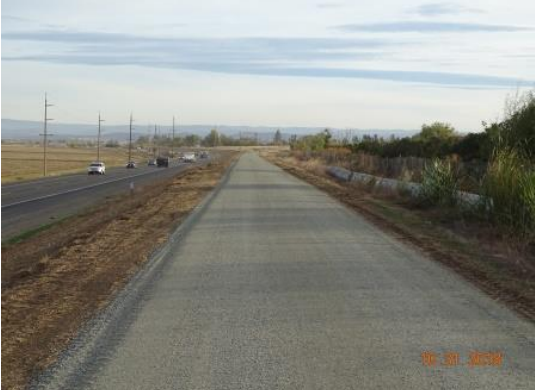
Photo 1 of 1 : FA\_2018\_NA0004\_106\_19\_20181108\_00045.jpg

View looking upstream at the resurface aggregate base crown, Fall 2018

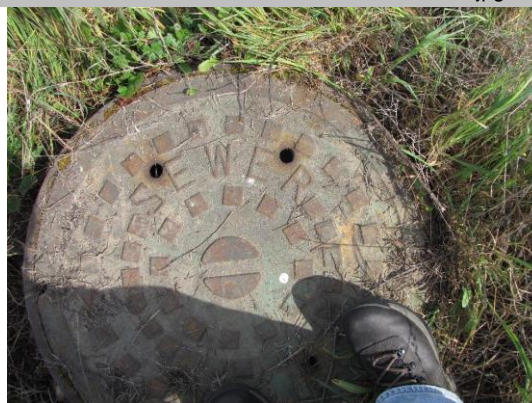
Photo 1 of 2 : UCIP\_FA\_2018\_52828\_25149.jpg

Manhole located on landward toe.
